Bus facilities Amsterdam Airport Schiphol

Explanation 'Overview bus gates en bus injection points'

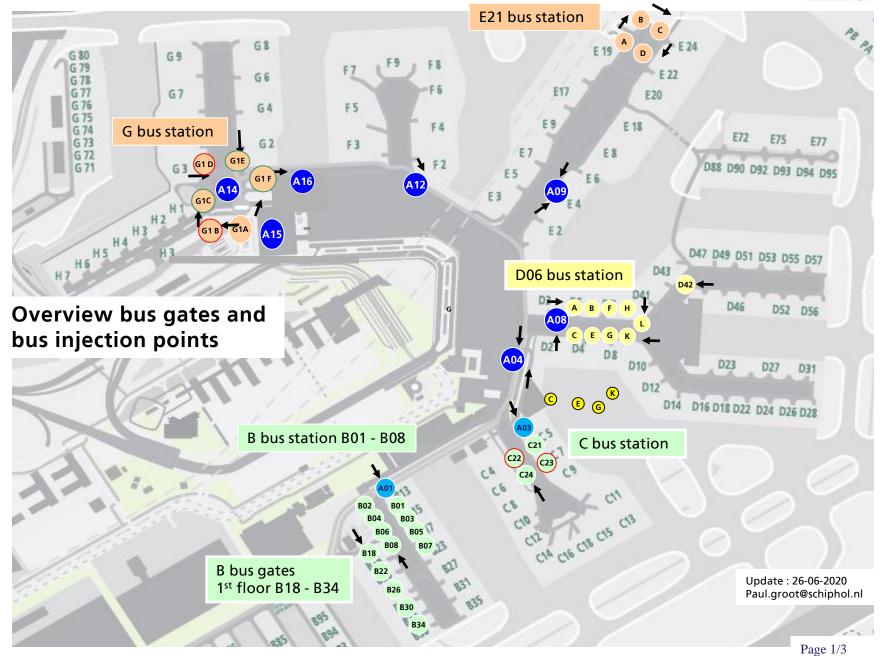
Arrival Bus Injection Points (BIP)	Symbol	s bus gates / bus injection points	Total number of bus gates
A01: backup 1 BIP A04		Schengen bus gate	Schengen bus gates: 17
A03: backup 2 BIP A04	L	EU/NEU bus gate	EU/NEU bus gates: 9
A04: Schengen		NEU bus gate, EU not allowed	NEU bus gates: 7
A08: EU + NEU flights with the status 'Security Conform EU' from A/B/D/E aprons		Bus gate with 2 exits	Bus gates with 2 exits: 4
A09: SkyTeam flights with the status 'None Security Conform EU' (backup A15)		BIP (Bus Injection Point)	WIBO bus gates: 7 (D42, E21, G12, G16)
A12: backup A08 and A14		BIP reserve	Total number of BIP's
A14: NEU flights with the status 'Security Conform EU' from G/J/Y aprons	\	Driving direction buses	Main entrances: 6
A15: None SkyTeam with the status 'None Security Conform EU' (backup A09)		Bus gate with sliding door	Backup: 3
A16: Schengen flights with the status 'None

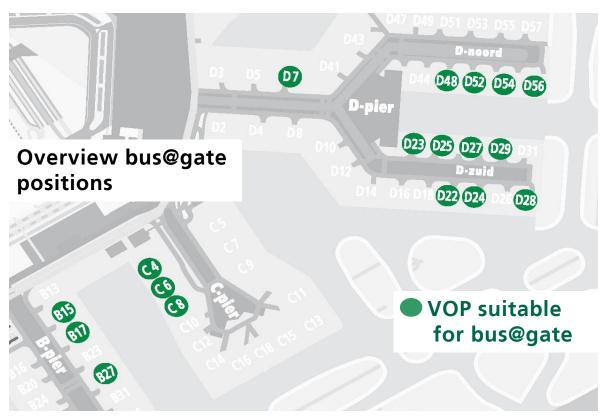
Arrivals bus@gate

B/C pier bus@gate positions: 6 x cat4 VOP's

- Arrival flights with the status 'None Security Conform EU'
- Arrival flights EU/NEU with the status 'Security Conform EU'

D pier bus@gate positions: 11 x cat4 + 1 x cat7 (D07) VOP's

- Arrival flights with the status 'None Security Conform EU'
- Arrival flights Schengen (D23 D28)

When a flight arrives at a pier gate and the passenger border status not corresponds with the border status of the terminal area, or if the security status does not meet the requirements 'Security conform EU' all passengers are transported by bus to a BIP corresponding the correct status.

At Schiphol, 18 pier gates are adapted to ensure a safe route to the bus.

Bus@gate facilities:

- Covered stairways (except C06 and D48)
- Additional handrail unto the platform
- Hook on the bridge door
- Security employee for guidance

- Safe walking route to the bus
- Guide lines
- Parking spot for the bus next to the stairs
